9/11 – Acceleration Study Proves Explosive Demolition

Frank Legge (Ph D)
Logical Systems Consulting
Perth, Western Australia.
flegge@iinet.net.au

Version 2.1

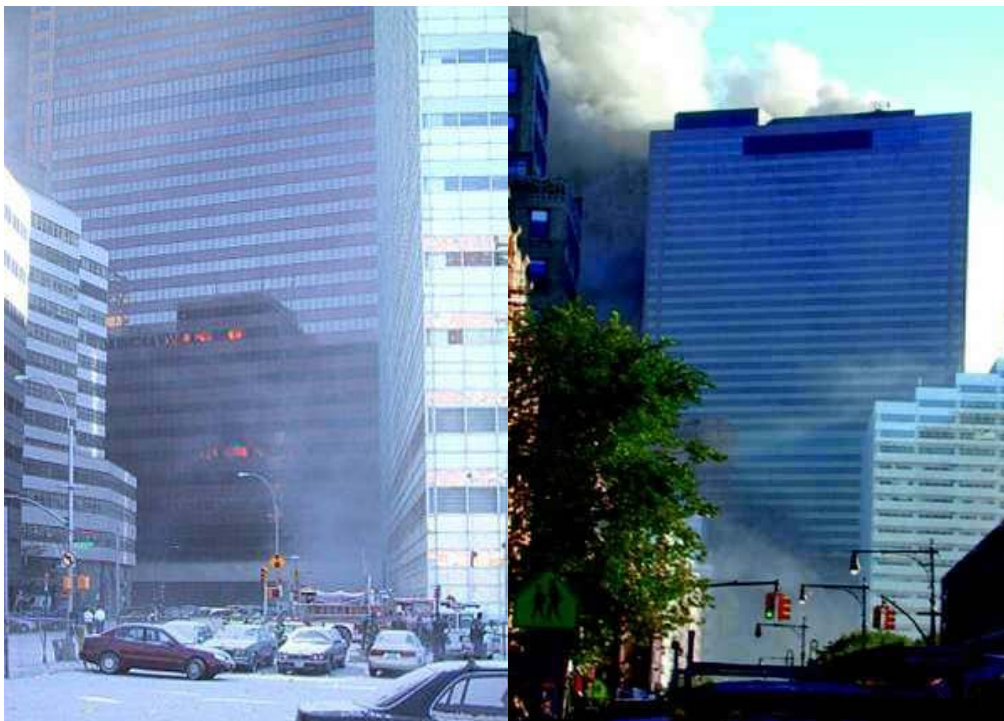
Small fires can be seen in the photograph on the left, taken in the mid-afternoon. In the whole area where the view is clear there are no broken windows. The photograph on the right was taken later, just prior to the collapse.² Again we see no sign of broken windows. This is of particular interest as a hot fire will break glass. The white cloud is probably rising from the rubble of the twin towers, known to be smoking, located just to the south of WTC 7, but the possibility that fires on the south face of the building are contributing to it must be examined.

2. This photo is from the FEMA report, chapter 5. That it is late in the day can be deduced from the direction of the sun and the fact that the street lights are on. Below is a photo taken from almost the same position after the collapse had started. It can be seen that the shadow on the foreground building is at almost the same angle as in the one taken before the collapse. This was close to equinox, at which time shadow angles move 15 degrees per hour. These photos can be no more than a few minutes apart; no time for a sudden engulfing fire to occur.

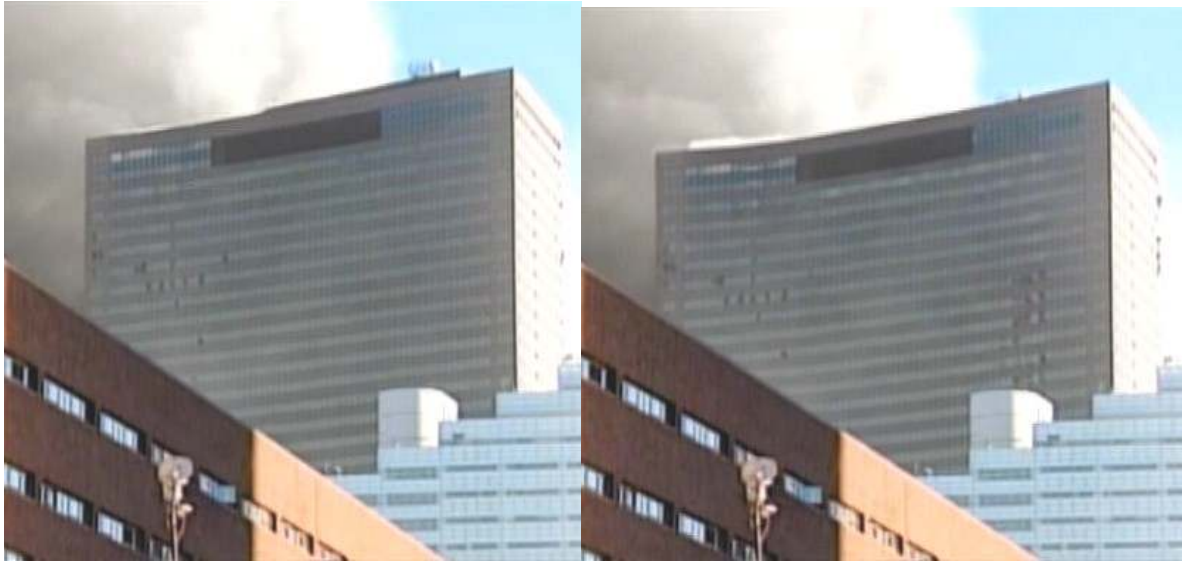
Below are two frames captured from a video of the collapse of WTC 7. In the one on the left we see that the eastern penthouse has disappeared and the roofline has sagged. This indicates that the collapse has just started. There are now a few broken windows clustered under the area which has sagged, indicating that the wall in that region is already becoming distorted.

The frame on the right, which was captured half a second later, shows more windows breaking, indicating further distortion of the wall. The fact that we can now easily identify breaking windows confirms that the previous assertion was correct that there were no broken windows throughout the visible area, just prior to the collapse. This in turn confirms that there had been no general hot fire, at least on this side of the building. The video goes on to show that further window breakages become evident and then become obscured due to dust emerging from the damaged regions. The fact that dust emerges so high up in a building in which the collapse zone is low down is also grounds for suspicion.

The remains of the penthouse, visible in the left frame, are seen to completely disappear during this half second. This is a remarkably rapid disappearance for something which, according to the official reports, is collapsing due only to fire and has no weight above it. That it is collapsing due to explosives appears to be confirmed by the appearance of a brilliant white flash in another video which starts a little earlier.³ That video shows that the eastern penthouse collapses first, largely obscured by dust. The flash is then seen, followed by the collapse of the western penthouse, progressing from the eastern end from the point where the flash occurred.

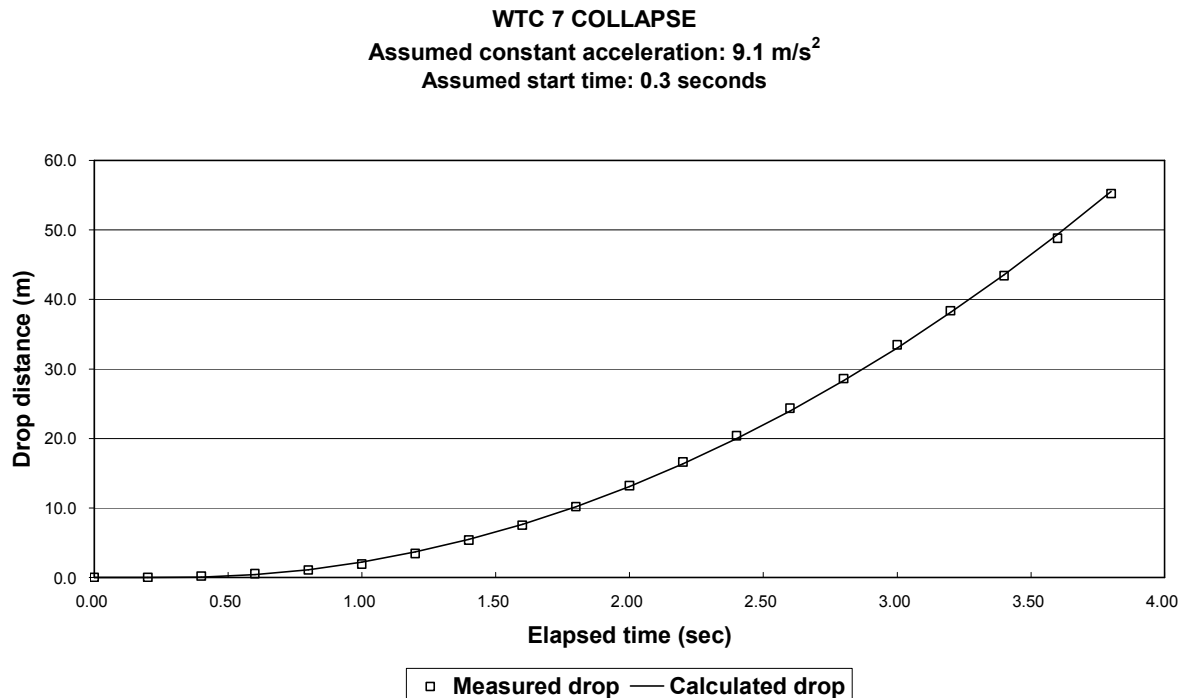
The video on which this paper is based can be viewed at the 911 Research site.⁶ The sag of the roof line can be seen to deepen and widen and spread toward the sides of the building. There is initially negligible motion of the corner nearest the viewer but from the moment it starts to move the collapse of this corner is uniform and close to vertical free fall as shown in the graph below.

The observed acceleration, 9.1 m/s², if maintained, would bring the roof to the ground in 6.2 seconds, very close to free fall in a vacuum, 6.0 seconds. There is no sign of the slow start that would be expected if collapse was caused by the gradual softening of the steel.

The graph above fits the data points closely. The line is drawn with an equation which assumes constant acceleration⁷ and the assumed moment at which the collapse commenced is 0.3 seconds into the displayed elapsed time. As the acceleration is constant the net downward force must have been constant. Gravity is constant which implies that the upward force provided by the structure was also constant. It is inconceivable that fires could heat the structural supports so uniformly throughout the height of the building that the collapse would encounter uniform vertical resistance. Fires by their very nature tend to creep from place to place as they run out of fuel and move to fresh sources, leaving the burnt out area to cool down. Steel regains strength as it cools.

5. WTC 7 was 174m high and had 47 storeys. Study of photographs and diagrams in the FEMA report shows that there was additional height in floors near the ground, in the middle and at the top. This additional height was equivalent to about 1.7 storeys, thus the height of a standard storey was 3.67m.

where s is the distance, a is the acceleration and t is the elapsed time. The fitting of the equation to the data was done using a least squares method. This gave a value of 9.063m/s^2 , which has been shown to two significant figures in the text and graph.

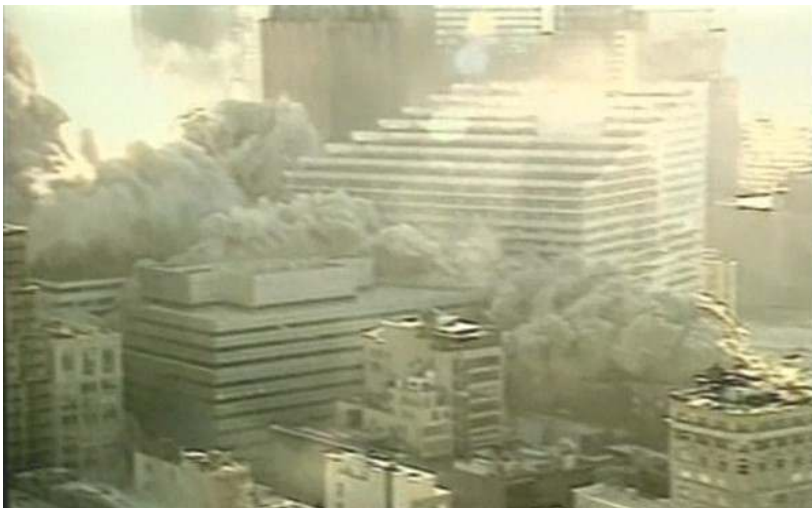
4. The frame below shows the dust running rather like a liquid along the “valley” between the buildings indicating that, for dust, it is unusually dense. The high density is also indicated by the speed of flow seen in the video

It is also worth noting that the behaviour of the dust cloud after the collapse was unusual. It rolled rapidly away hugging the ground, suggesting that it was denser, and thus more propelled by gravity, than is normally observed in controlled demolitions.⁴ This is clearly reminiscent of the energetic dust clouds rolling from the twin towers, though the effect is not as pronounced. One suspects that more explosive than usual was employed in all three buildings to guarantee that the collapse would be well controlled and thus would exhibit no hesitation or tendency to lean. The extra explosive would pulverize more of the concrete than usual and so produce a denser dust cloud than seen in commercial demolitions.
